TECHNICAL SERVICE BULLETIN

2.7L/3.0L EcoBoost - Oil Pan Leaking

19-2219
09 August 2019

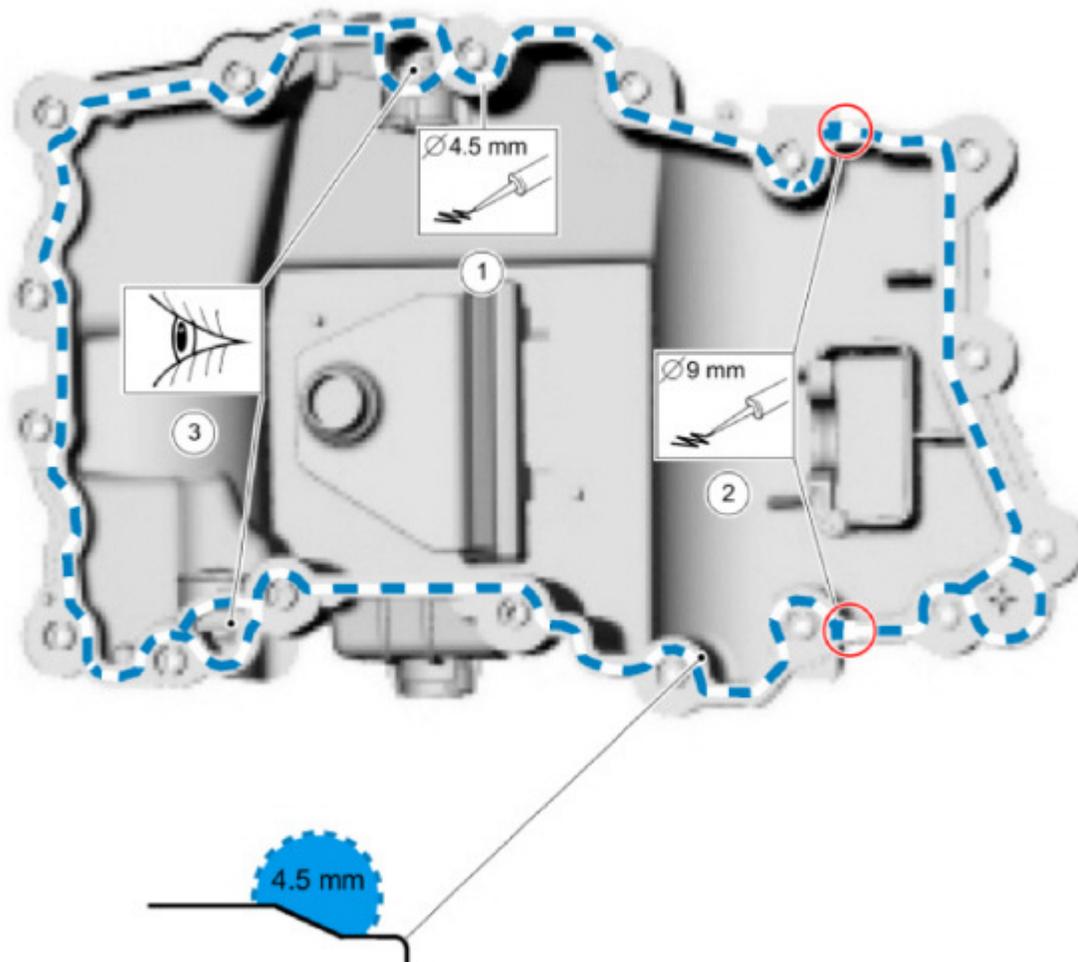
Figure 5

(1). Using too little sealant may result in oil leaks and using too much sealant may result in oil contamination and engine damage.

8. Apply a 4.5 mm (0.18 in) bead of Motorcraft® High Performance Engine RTV Silicone to the new oil pan. The RTV bead must be applied to straddle the step chamfer and sealing face. (Figures 5-6)

9. Apply a 9 mm (0.35 in) bead of Motorcraft® High Performance Engine RTV Silicone to the engine front cover-to-cylinder block joint areas on the new oil pan as shown in Figure 5.
10. Install the new oil pan. Refer to the WSM, Section 303-01.
